BP-Aral, Gotha, Germany

KPS' Easy Install Piping Prevents Downtime for BP-Aral During Piping Upgrade in Gotha, Germany

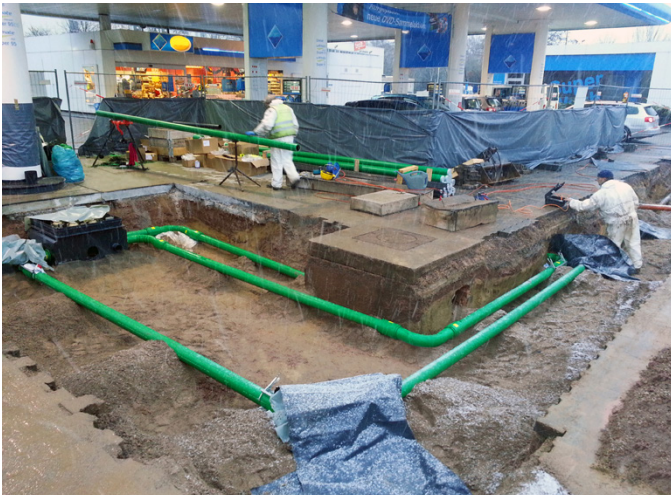
KPS' quick and easy installation resulted in no interruption of fuel sales

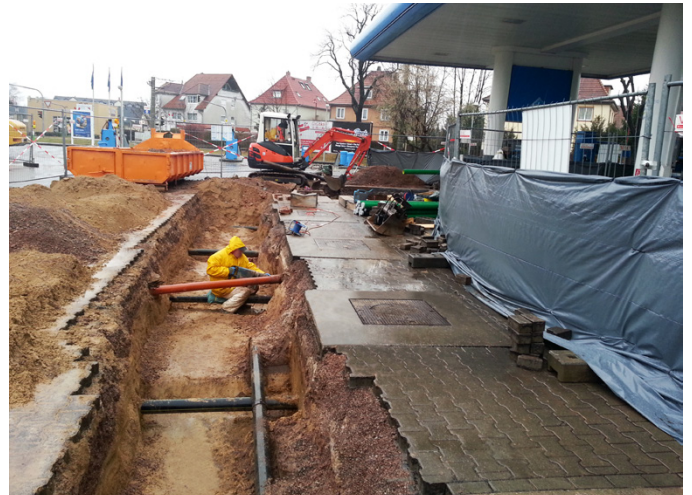
KPS piping was installed one level above the steel piping, preventing interruption of fuel sales

KPS double wall piping was installed one level above the existing steel pipes, then once the plastic piping was in position, the tank was disconnected from the old piping and connected to the new KPS piping above, preventing interruption of fuel sales.

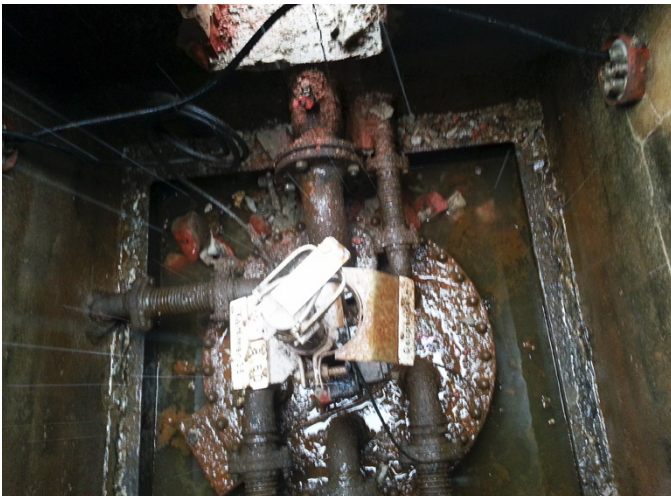
Previously installed steel piping had become damaged over time and started to rust

The previously installed steel fuel piping had become damaged as a result of rust over the last twenty years, causing the pipes to leak. No down time or interruption of sales was a key requirement of this project so a solution had to be put in place before the old piping was disconnected.

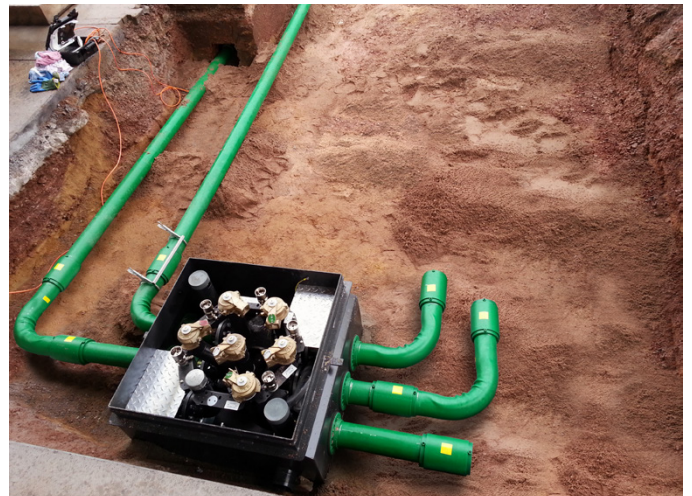
Once the plastic KPS piping was in position, the old steel piping was disconnected and the new KPS piping was connected
