Case study

Ireland: Maxol leading the way

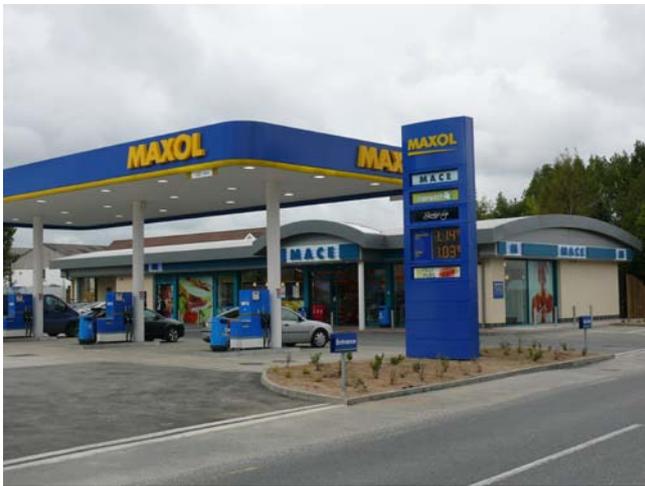
In 2009 one of Maxol's service stations reported problems of audible static discharges. The problem was that during the filling of the underground tanks an audible and repeated 'clicking' could be heard in the fill box. The clicking ceased when the filling process was completed. Concerned, Maxol contacted KPS immediately to discuss potential causes and their immediate resolution.

The station was operating with non-conductive piping and it was quickly concluded that there was a need for grounding and bonding of the metal work surrounding the pipework in the station's fill boxes.

In early 2010, whilst filling the underground tanks at evening time a lorry driver observed a spark jumping some 50 mm (indicating a charge of approx 50,000 volts) in the fill box. Immediately Maxol closed the station until further analysis could be undertaken and measures to eliminate the problem identified.

KPS commissioned the services of an independent electrostatic consultant, who concluded that the problem was likely to be related to static discharges from the non-conductive pipework used at the station. Previous grounding of all isolated metal work had not rectified the problem.

The consultant went on to recommend immediate replacement of the non-conductive pipe with conductive pipework, which would then dissipate any static electricity to earth.

The pipe replacement work was immediately undertaken by the installers Tokheim and KPS working in close collaboration with Maxol. Since the installation of KPS conductive piping, the Maxol station has had no further incidents of sparking and the station is fully operational with a 'clean bill of health.' The workplace for installers and other staff is now compliant with the ATEX 1999/92/EC Users Directive.
